Report on travel to the site of implementation of  
EBRD project “Rehabilitation of Kiev-Chop road” (phase 3)<sup>1</sup>  
Villages of Bolyarka and Berezivka of Zhitomirskia oblast  
March 13, 2012

By Olena Miskun, National Ecological Centre of Ukraine/CEE Bankwatch

Project sponsor – “Ukratodor”,  
Developer of project documentation (blueprints) – “Ukrhiprodor”, “Zhitomirhiprodor”  
Constructing company – “Gulsar” (Turkey)  
Consultant – “Hyder Consulting” (UK)

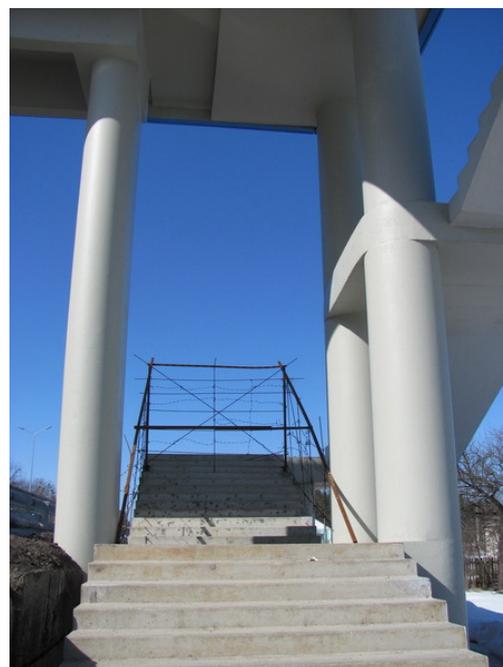
In the village of Berezivka there is an unfinished pedestrian bridge. It has been left as is by the constructor workers. The bridge has been closed for about a year.

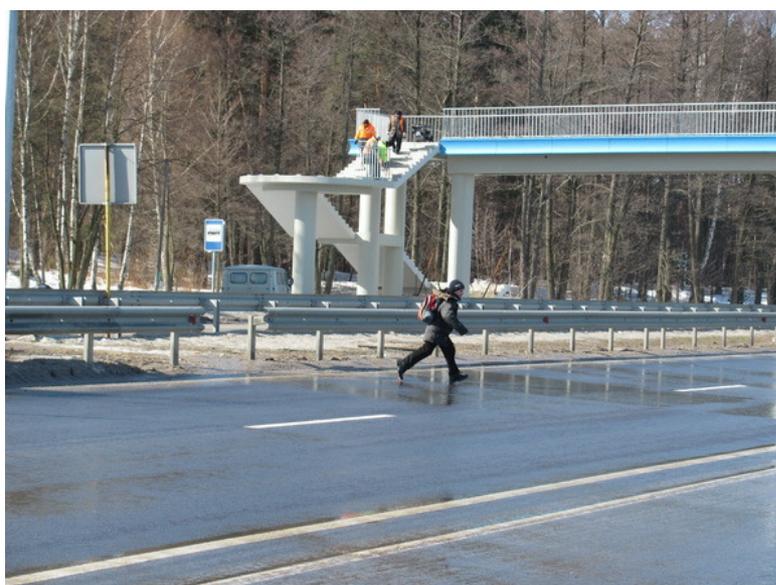
All this time children from the two schools that are standing right near it have been crossing the highway like this:

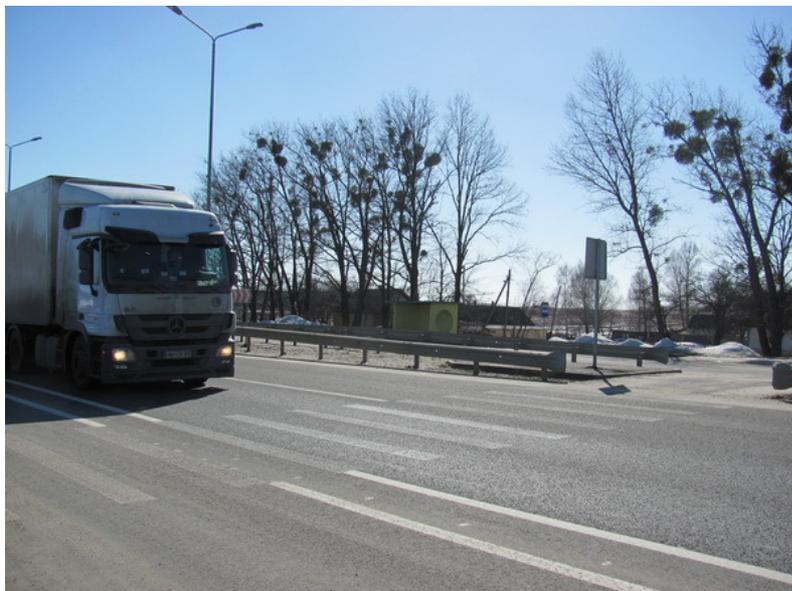
There are no pedestrian bridges in Bolyarka at all. The ground crossroads are not equipped with traffic lights, relief markings on the pavement or with any other marking.

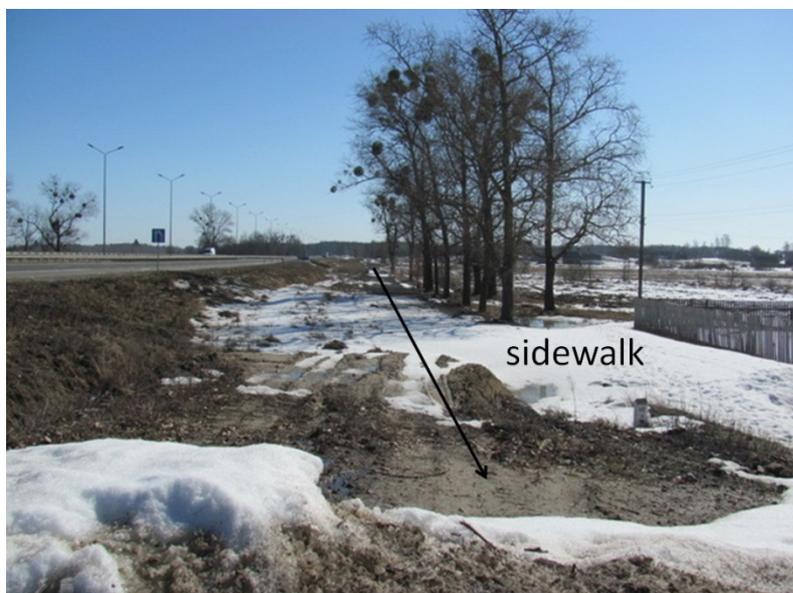
This is the sidewalk road that is supposed to allow local citizens to get from one street of the village to another across the highway at the crossroad.

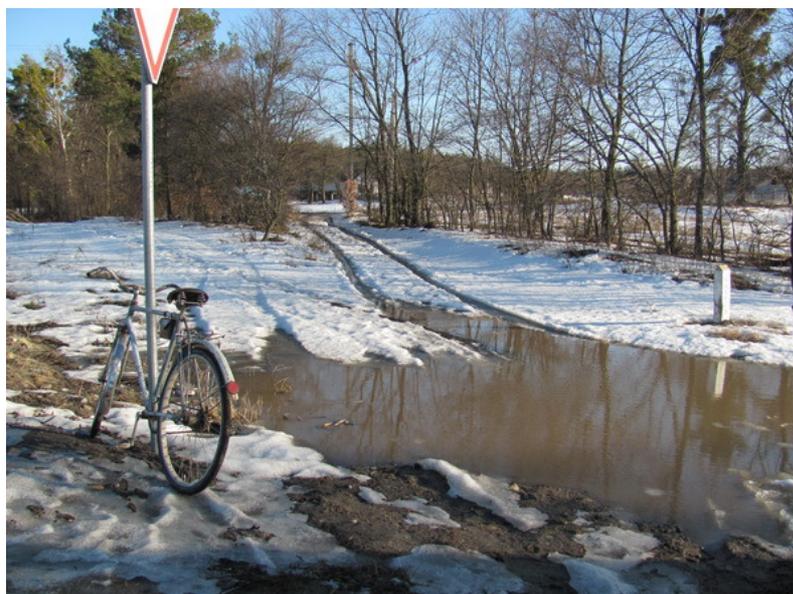
Another example of "missing" sidewalk several hundred meters from previous location.

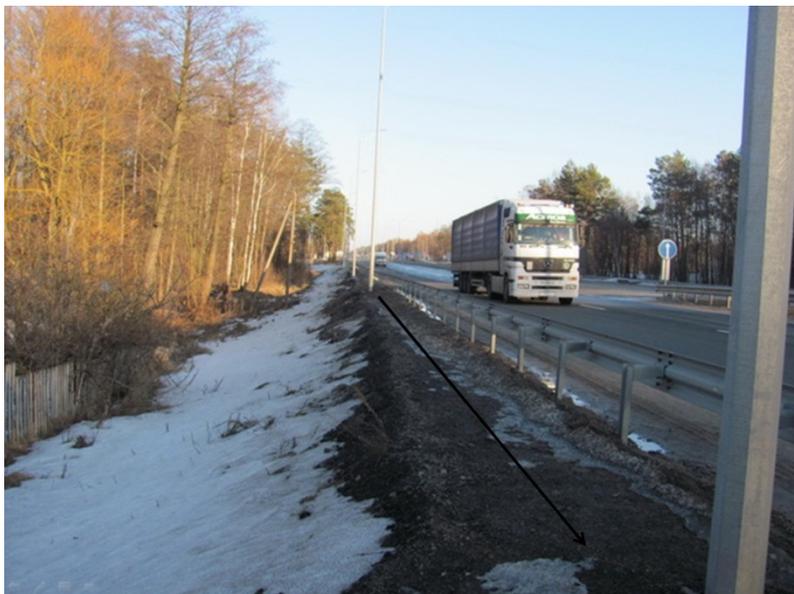
Existing sidewalk, that is made of the material that will be washed away by the end of spring as it is very soft and it is not asphalt. Moreover it is too narrow and the light pylons stand right in the middle of it. In winter the snow from the highway is piled on the sidewalk, so there is no physical space to walk by it. The snow cannot be removed from the sidewalk due to the lack of physical access (because of the fence), the nature of the material (because it will be removed with the snow) and pylons that are preventing the tractor from moving there.

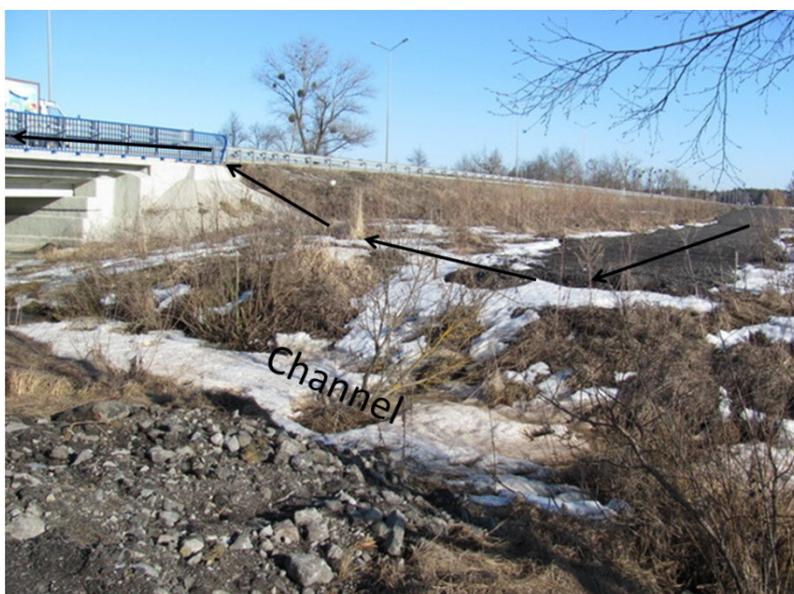
One needs to go by the existing bad quality sidewalk, then climb to the bridge of the highway, walk along the carriageway and then get back again to the sidewalk.

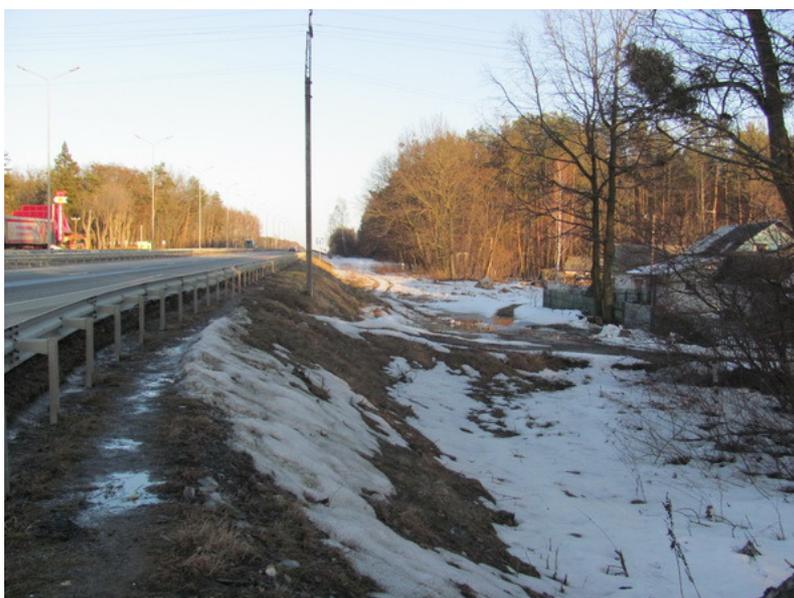
In some places the fence physically blocks the private houses. The households are cut away from the road, so no horse-driven carts or cars can get there.

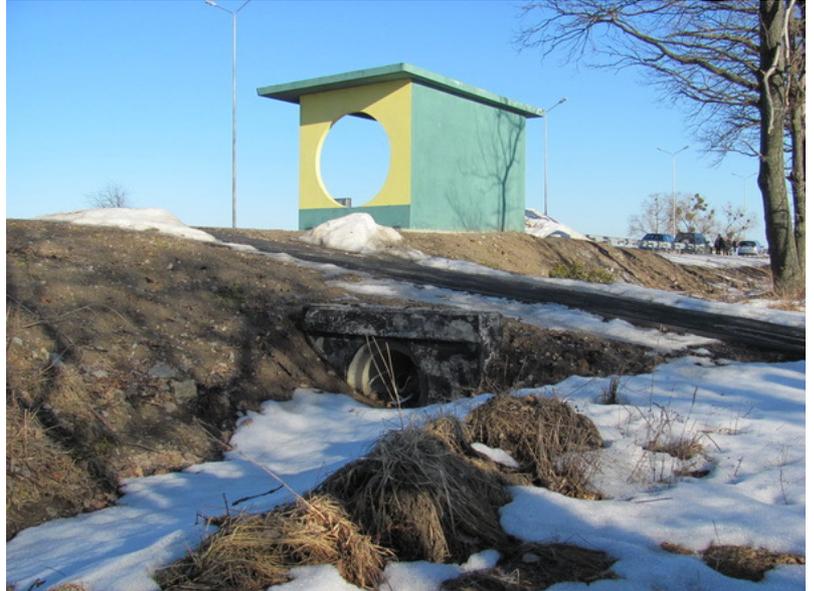
The pipe for drainage is put upper than the level of water, so all the water from the highway goes to the private land plots, flooding the gardens and houses.

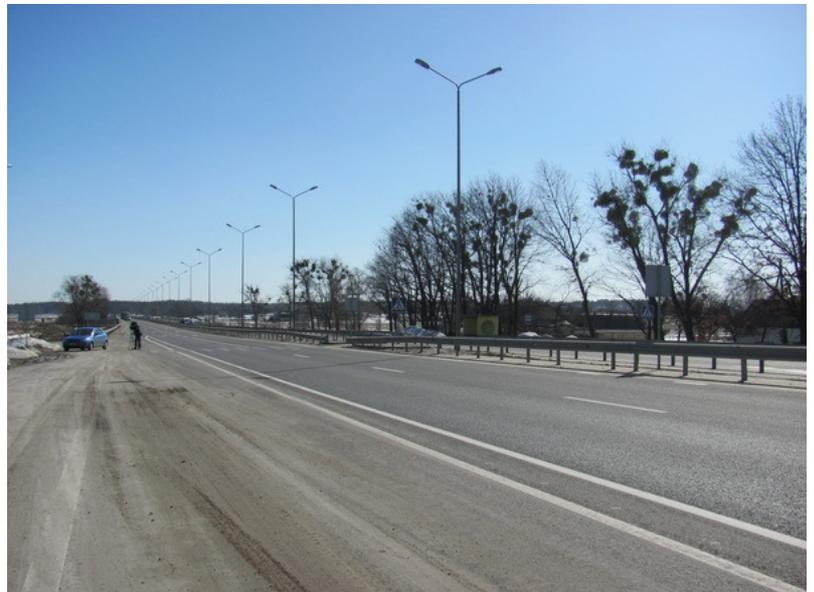
Noise protective shields are not detected in any place of the village although in some places the living houses are situated in 20 meters from the highway.

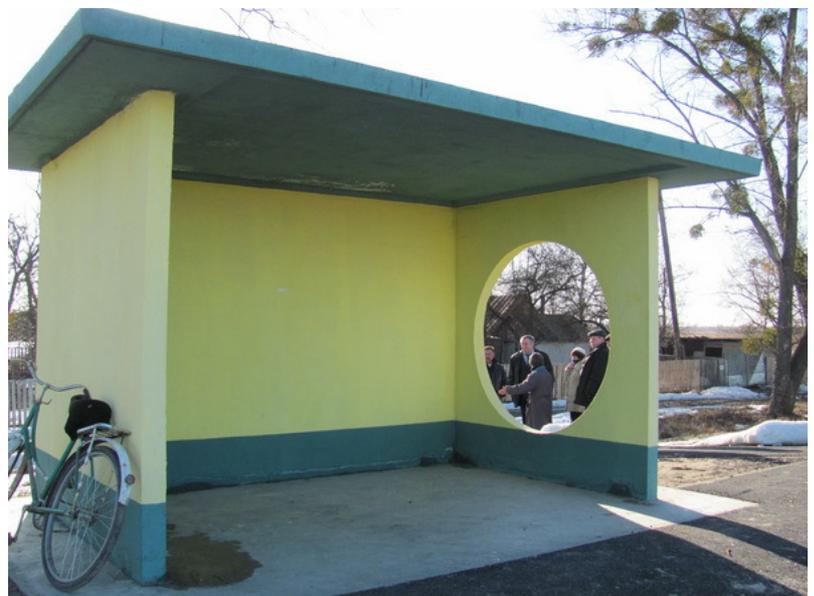
None of the stations for the public transport is equipped with benches or waste containers. In some places the toilets are missing, so car drivers use the stations as toilets.
